Village Green Metropolitan Park District

Village Green Metropolitan Park
26159 Dulay Rd NE | Kingston, WA 98346
Kitsap County Parcel: 262702-4-089-2009

Title – Tree Risk Assessment

Date – Jan 2023

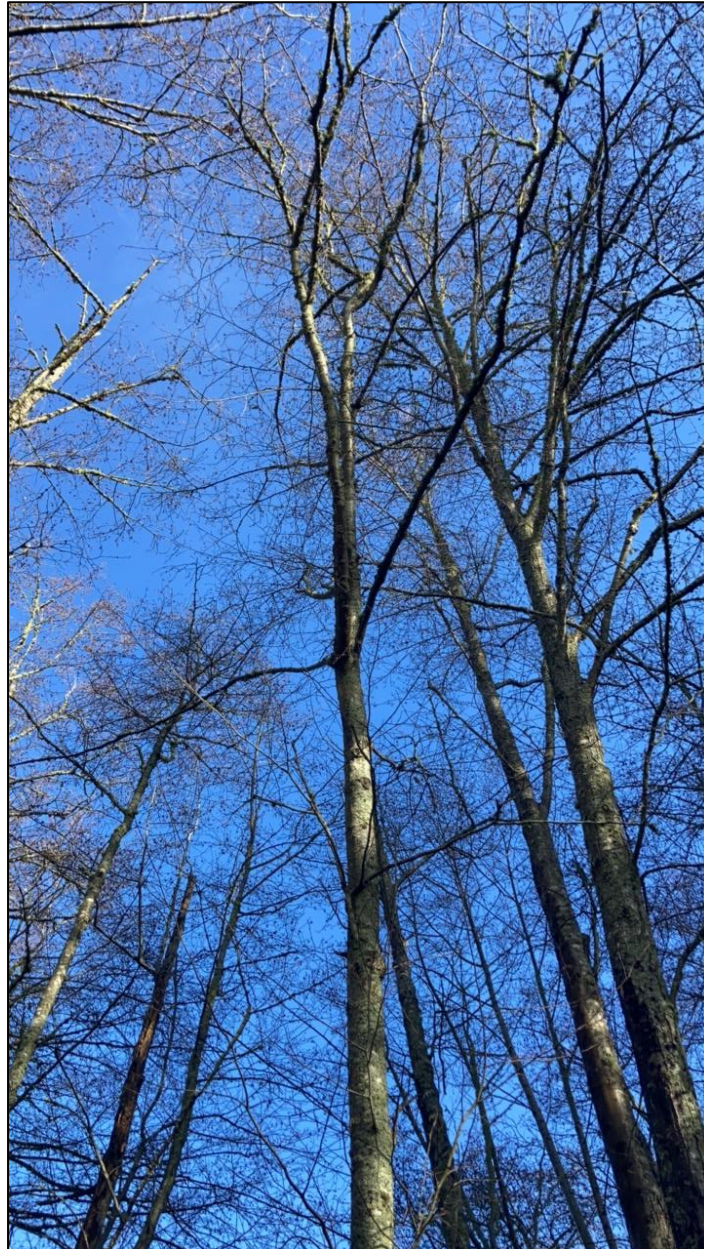
Photo 1: Tree 6601.

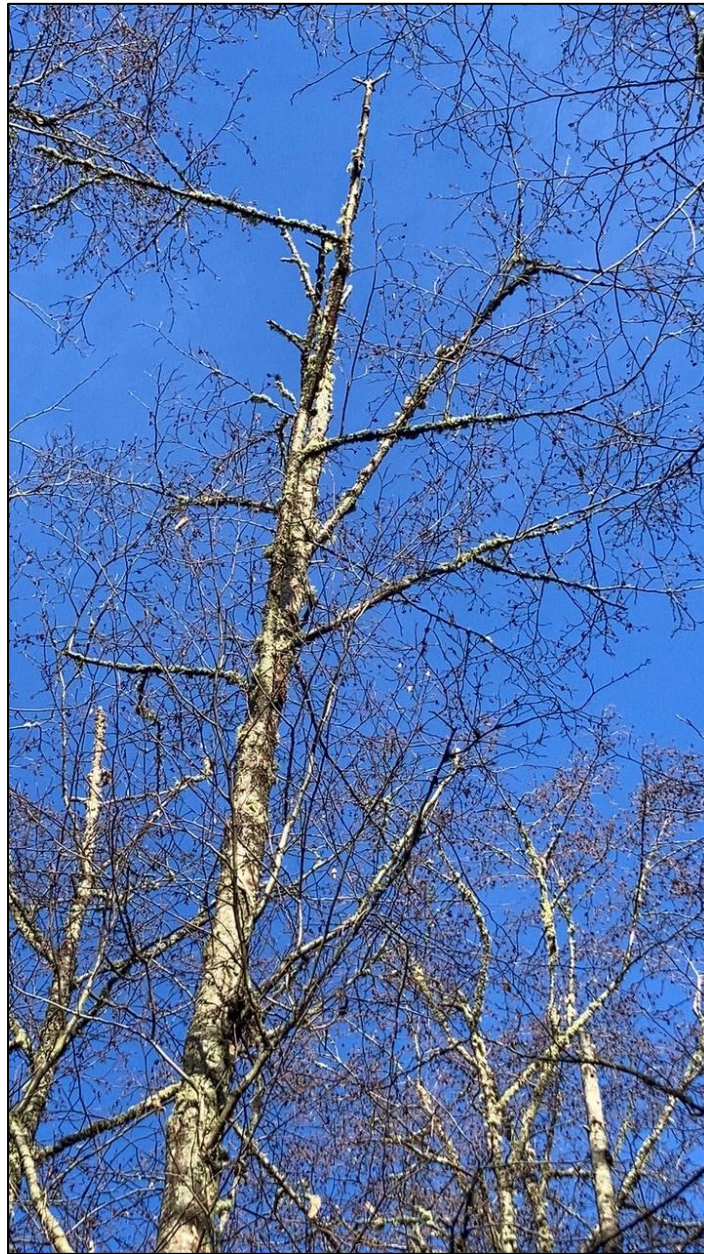
Photo 2: Tree 6602. Dead top.

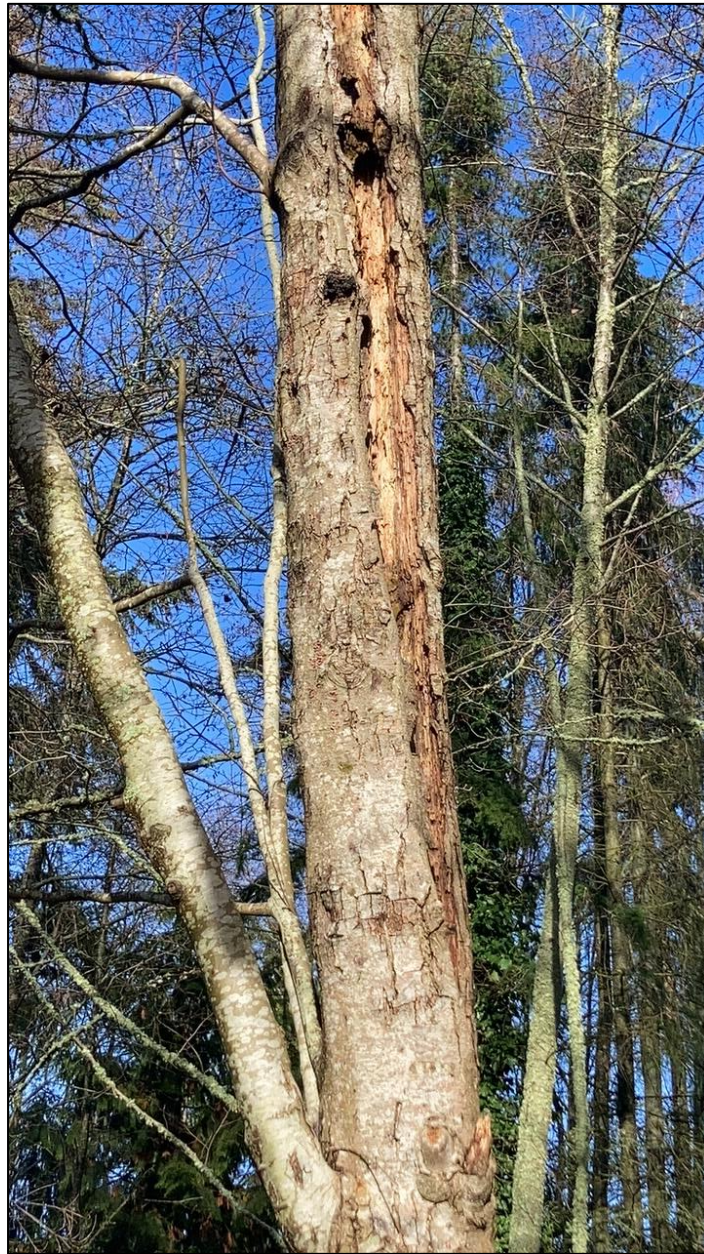
Photo 3: Tree 6603. Photo of decay.

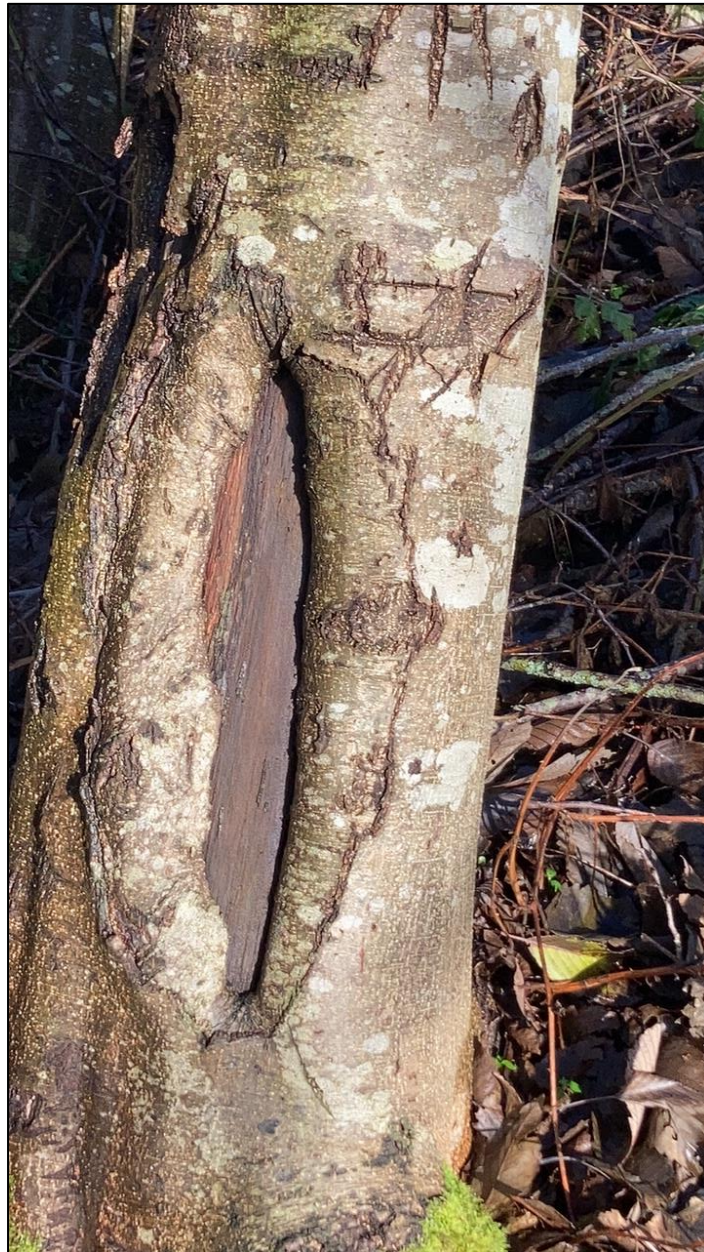
Photo 4: Tree 6604 with decay at base.

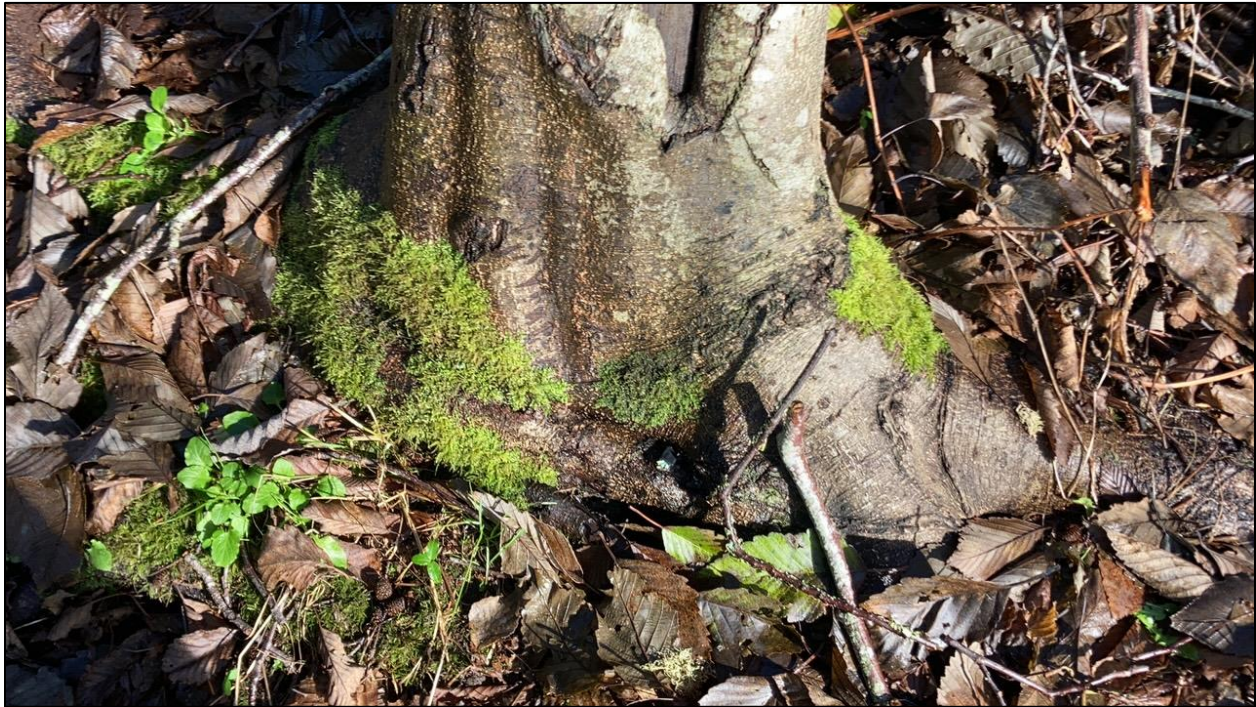
Photo 5: Tree 6604 with girdling root.

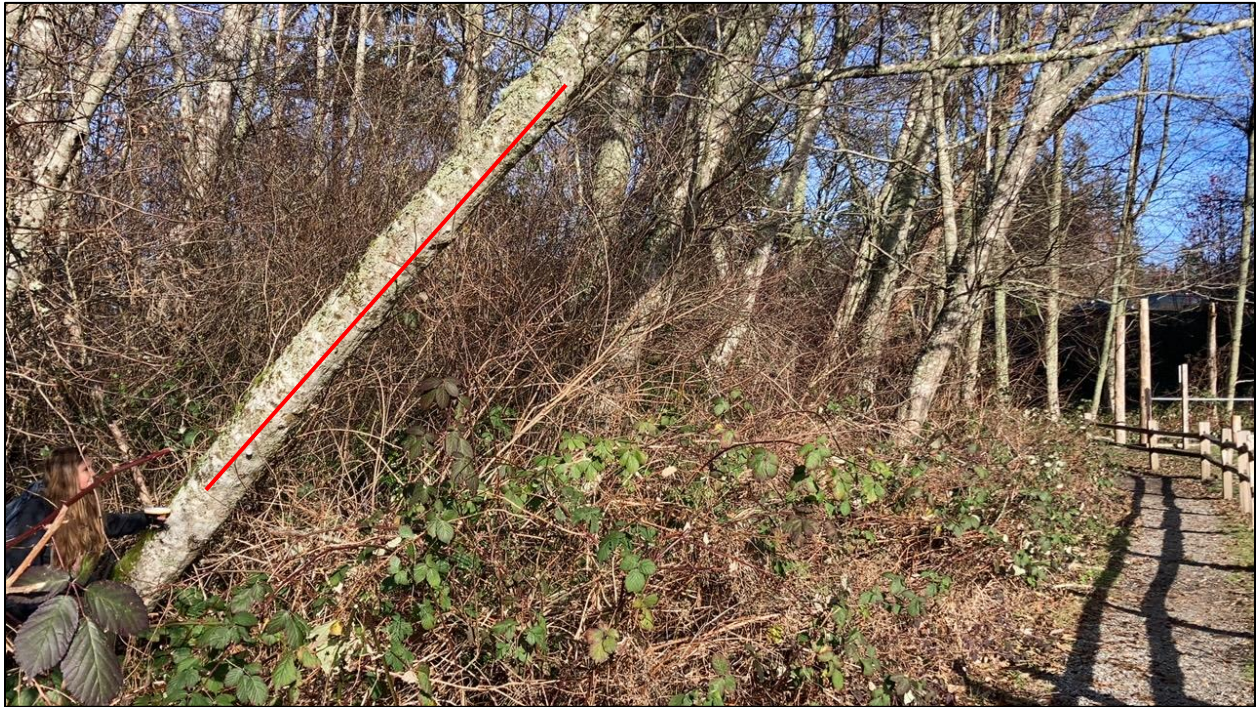
Photo 6: Tree 6607-leaning red alder with red line through it.

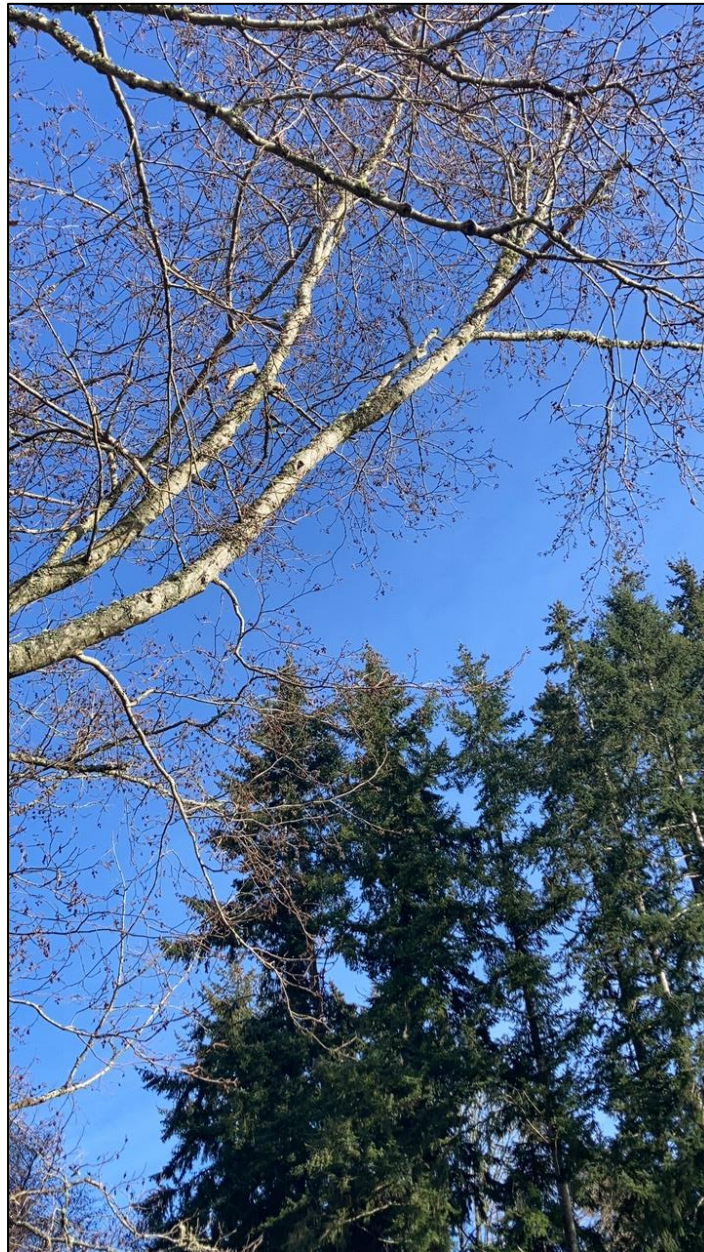
Photo 7: Tree 6607: canopy of tree over exercise structure.

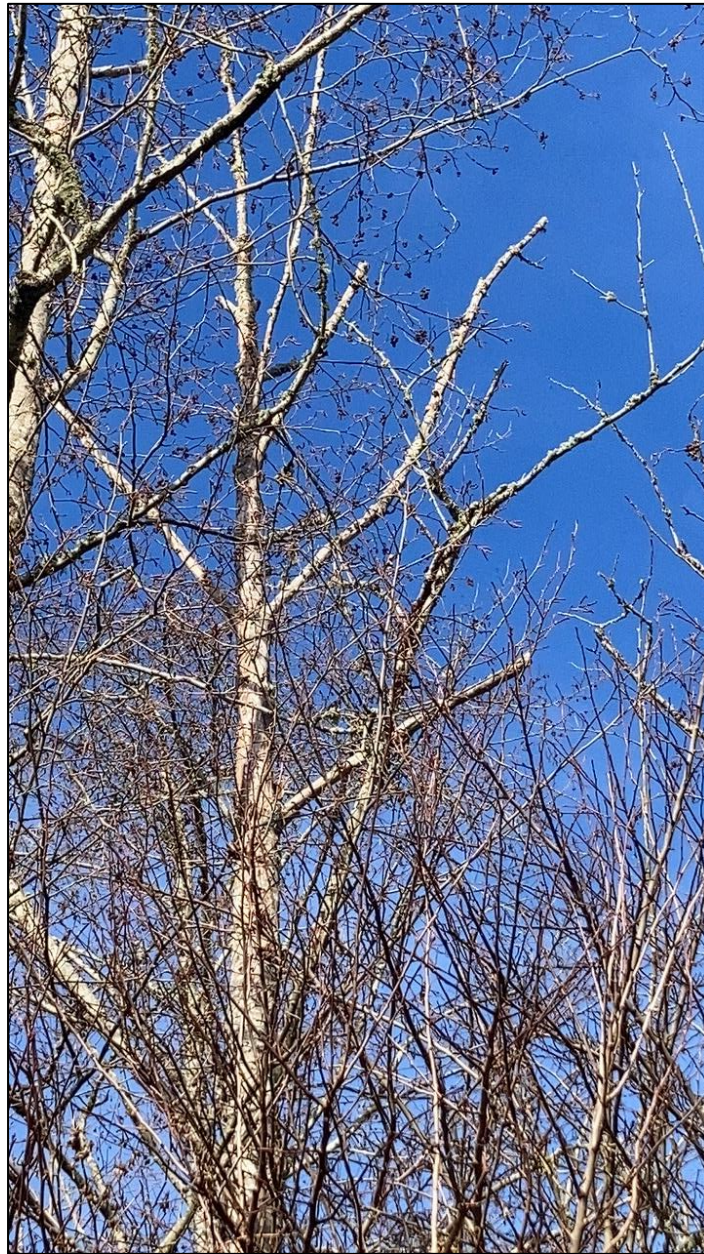
Photo 8: Tree 6608 with dead branches.

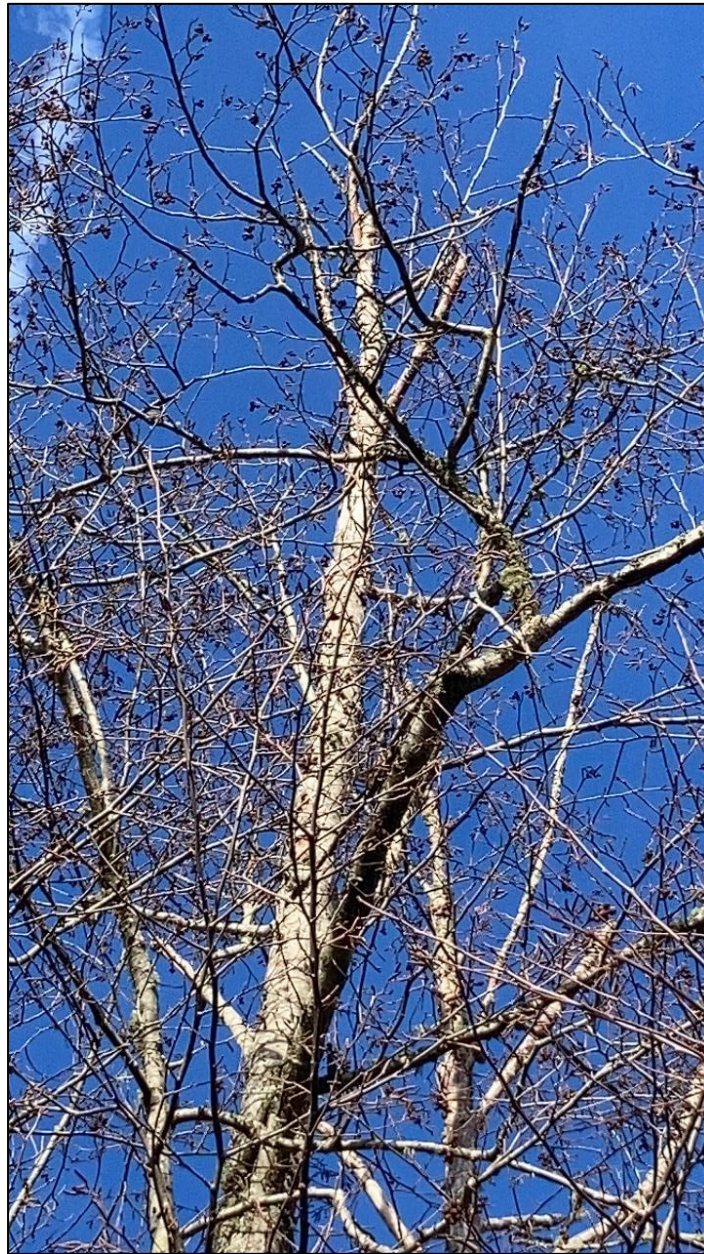
Photo 9: Tree 6609.

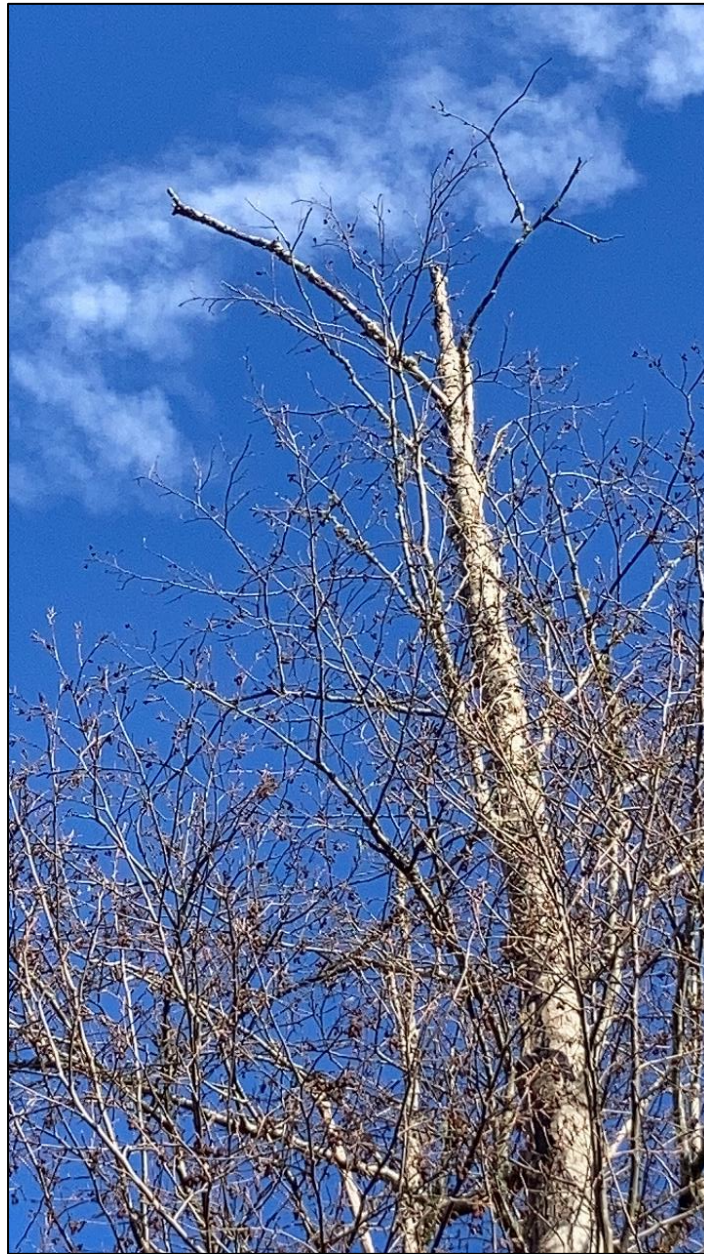
Photo 10: Tree 6610 with dead top.

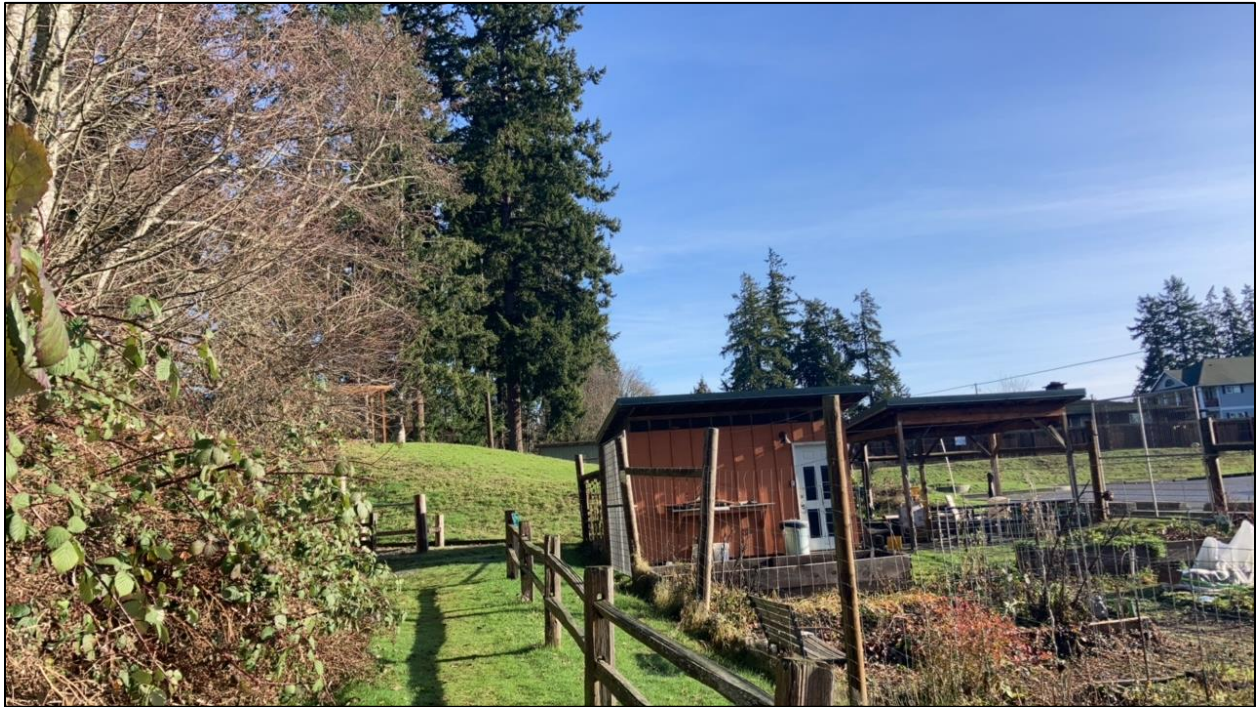
Photo 11: Tree 6610 with community garden target.

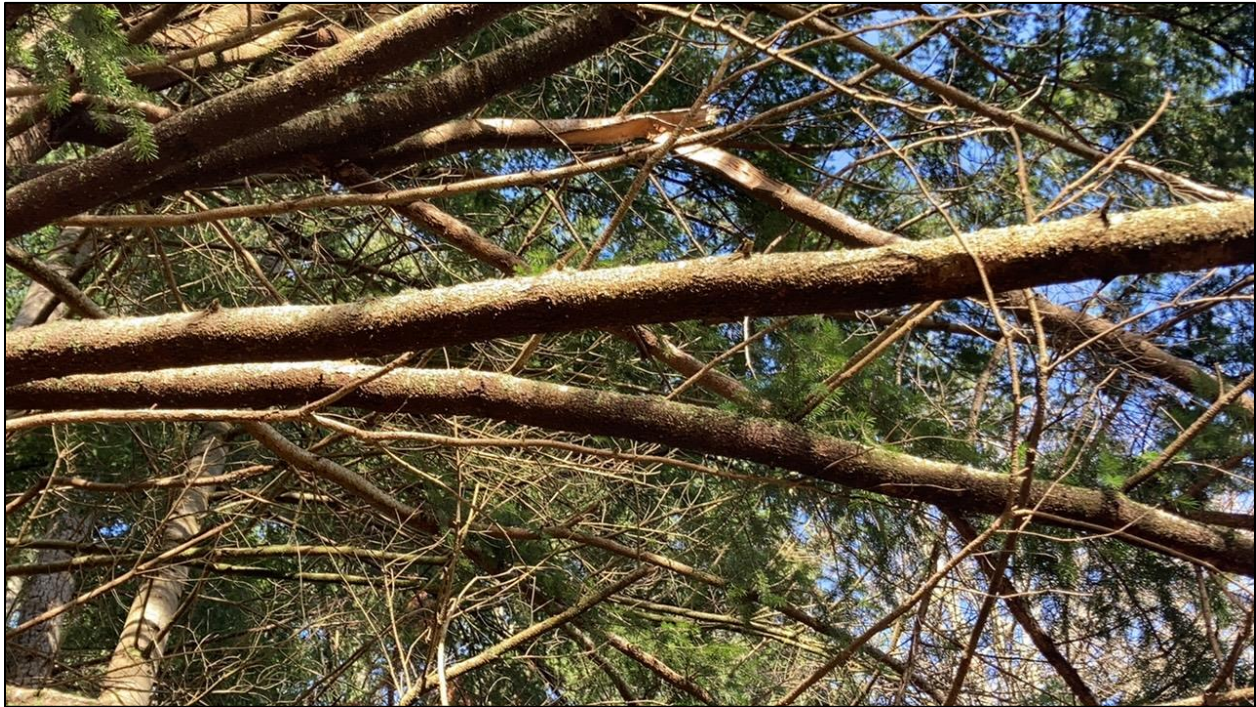
Photo 12: Tree 6611 with broken branch above trail.

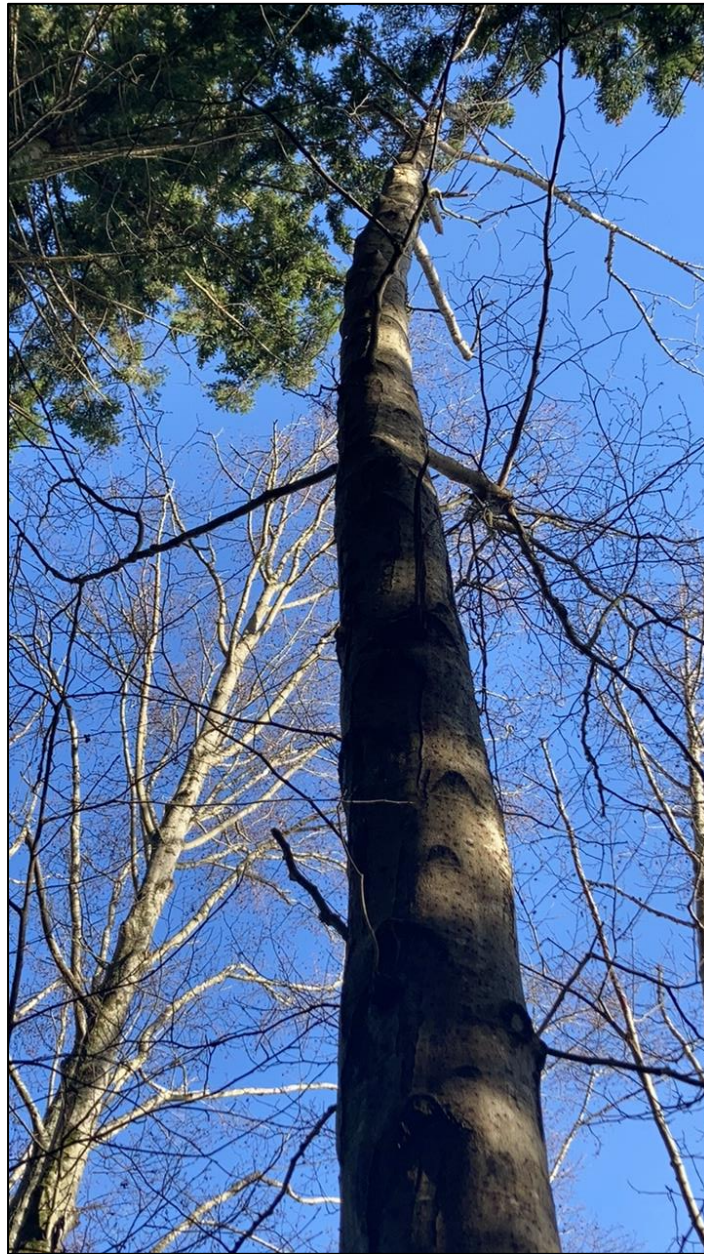
Photo 13: Tree 6612.

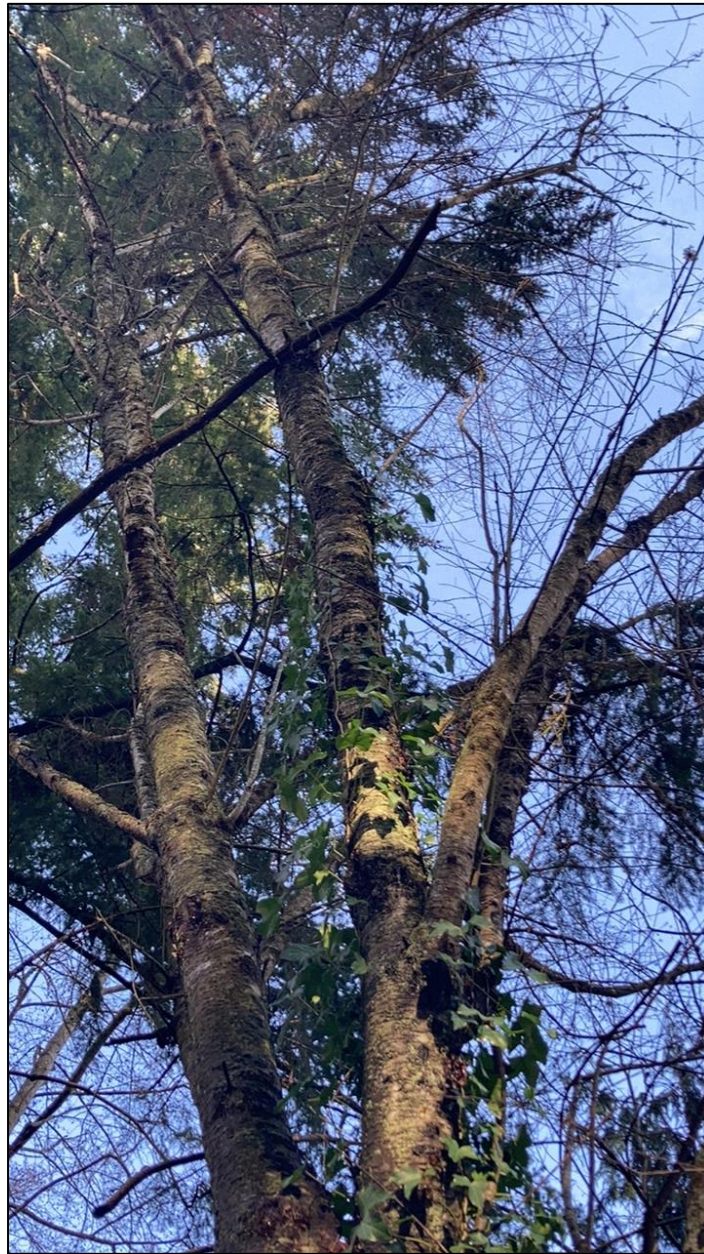
Photo 14: Tree 6613.

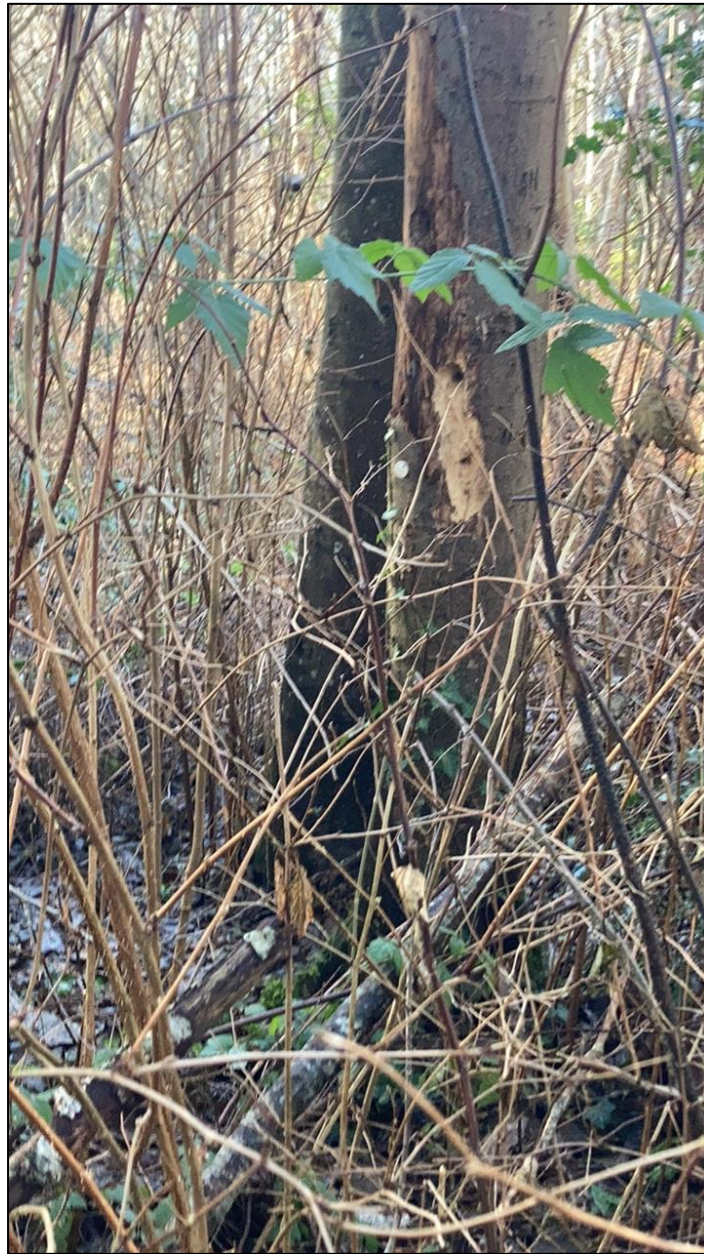
Photo 15: Tree 6614.

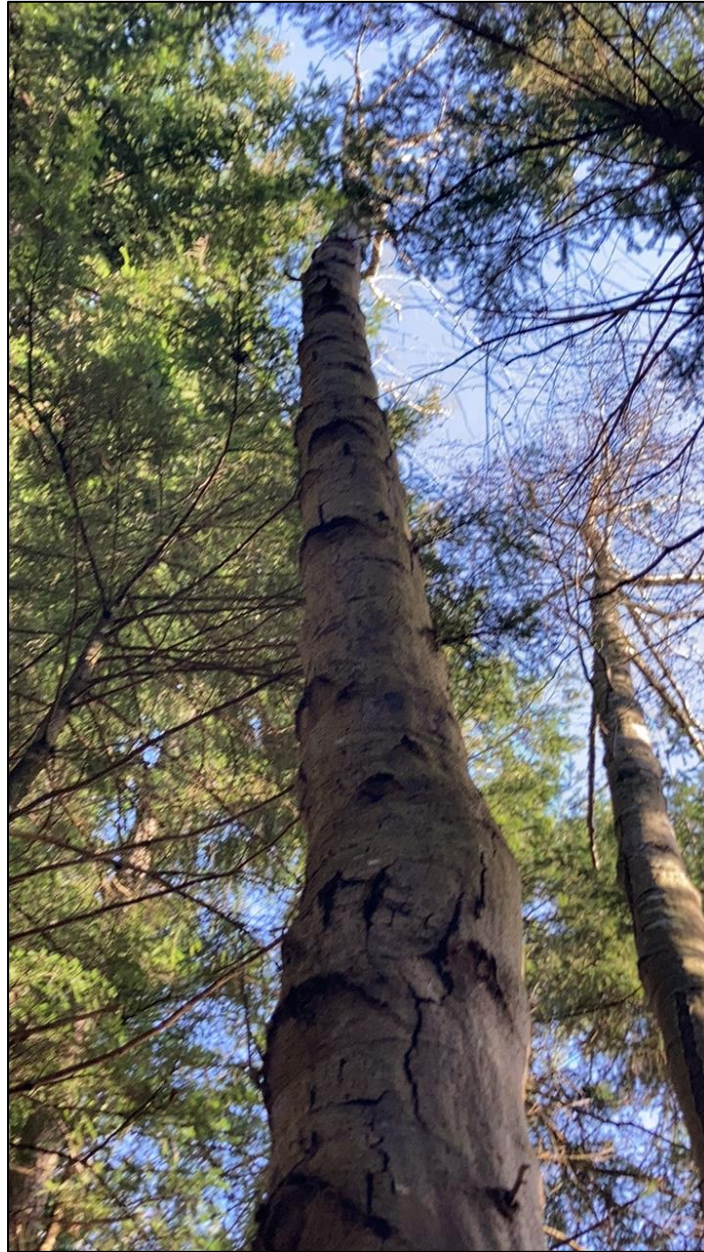
Photo 16: Tree 6618.

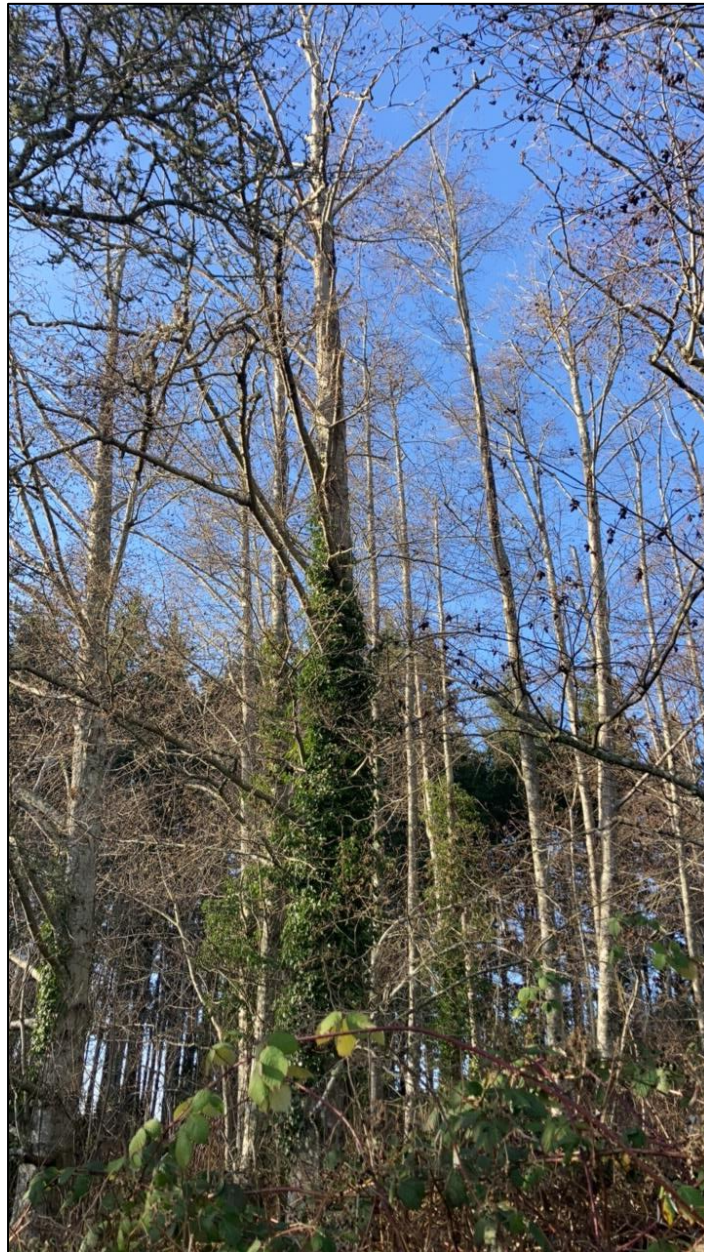
Photo 17: Tree 6619. Covered in ivy.

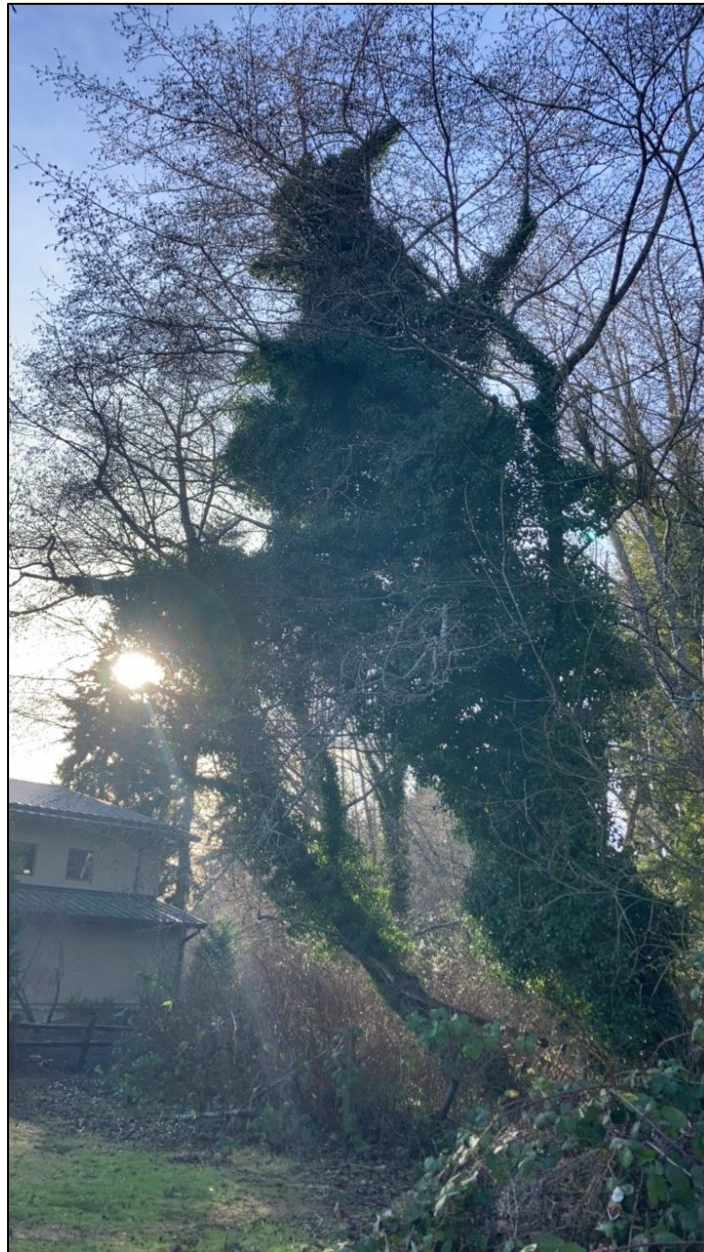
Photo 18: Tree 6620. Covered in ivy and building as a target.

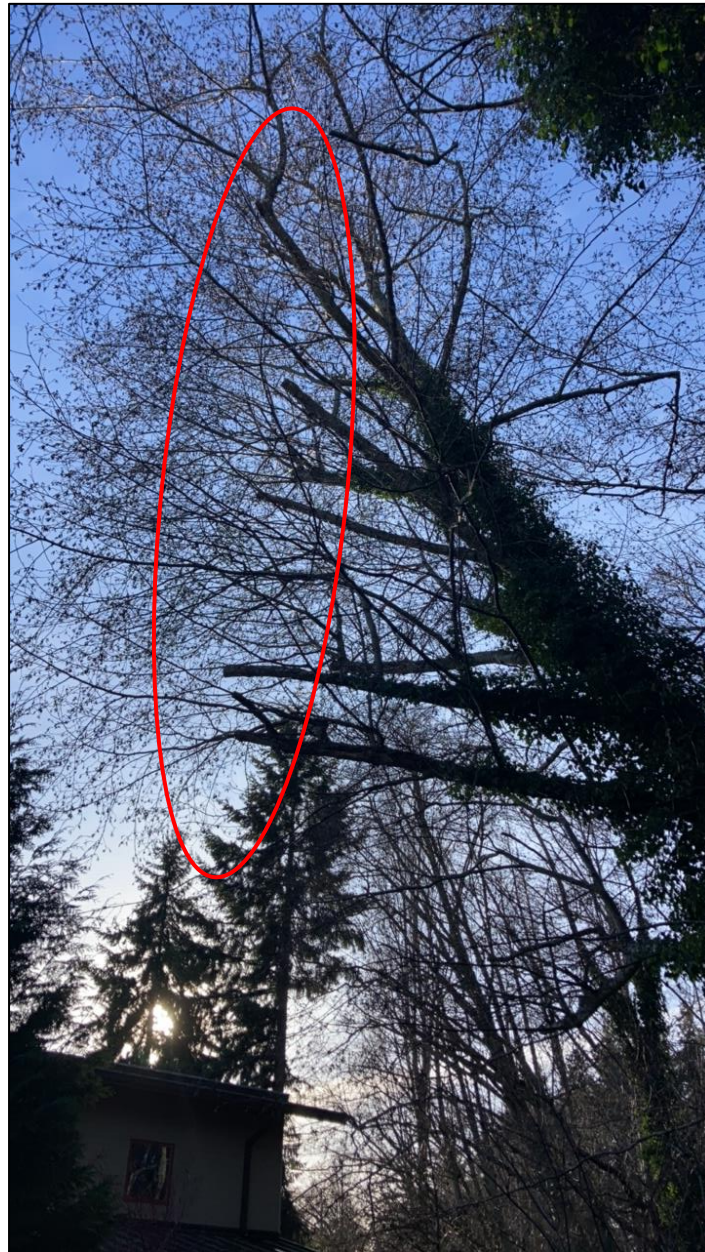
Photo 19: Tree 6620. Red line indicates approximate areas of stub cuts.

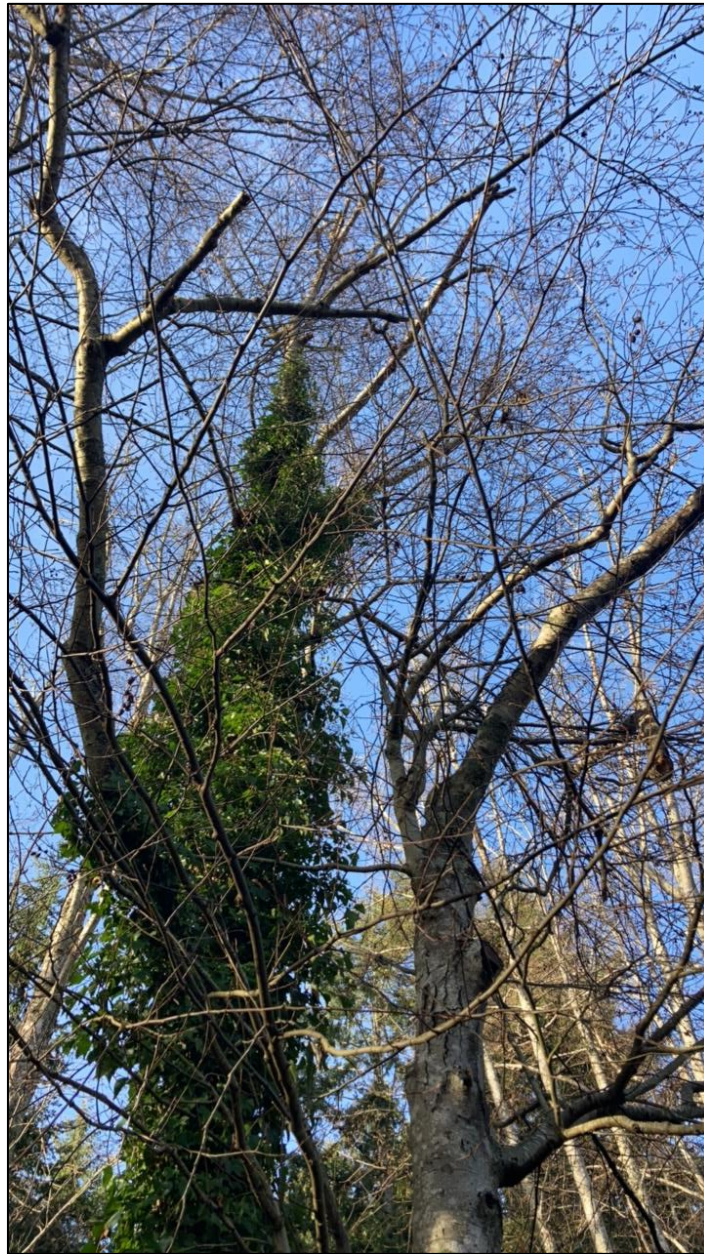
Photo 20 Tree 6621. One stem is covered in ivy.

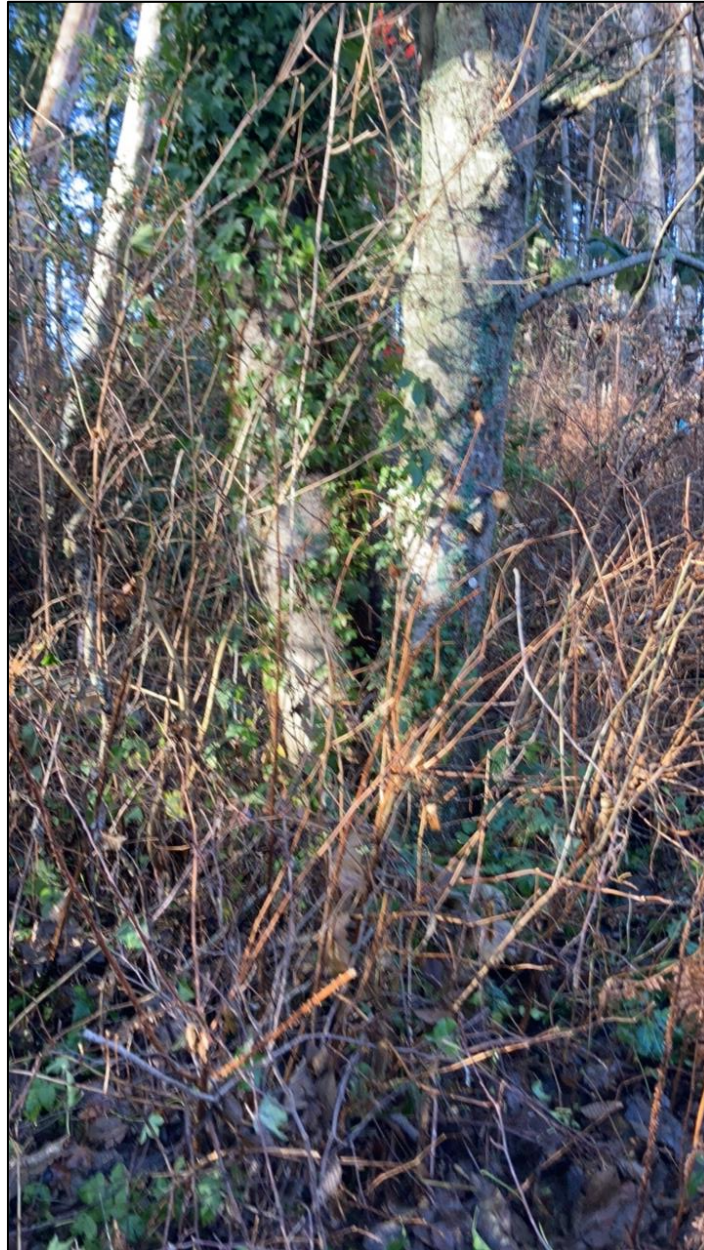
Photo 21: Tree 6621. Bifurcated at base and covered with ivy.

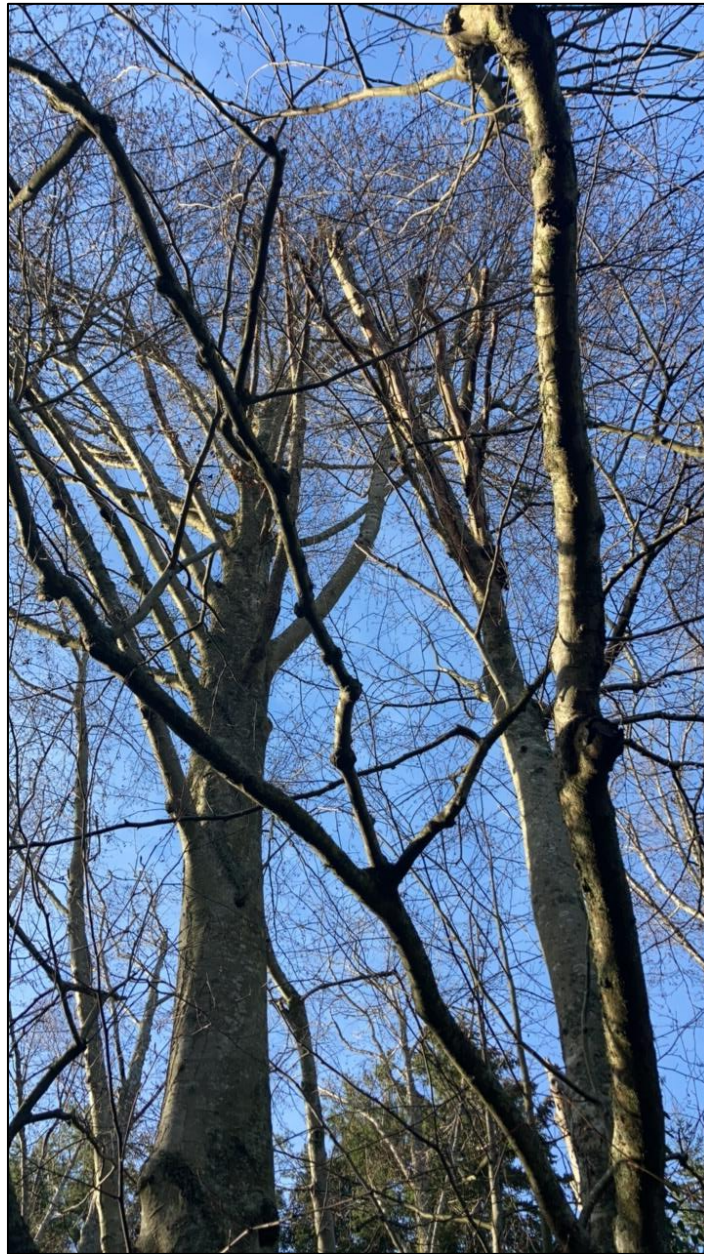
Photo 22: Tree 6622.

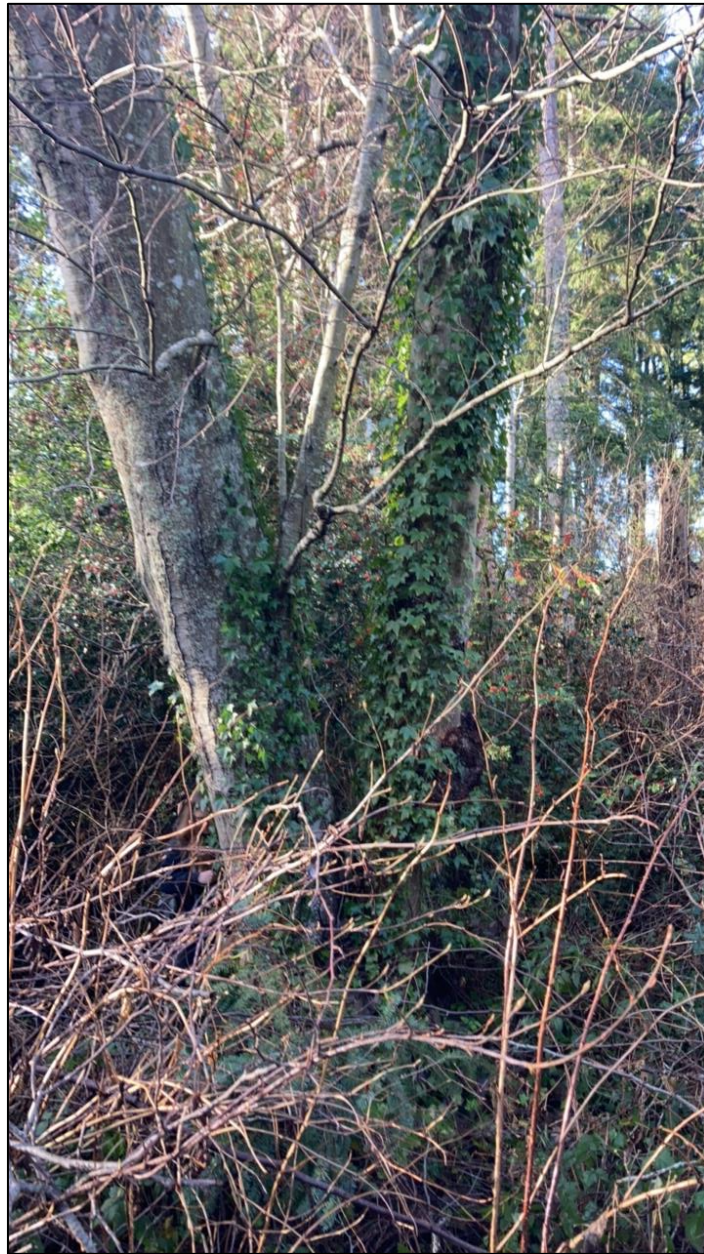
Photo 23: Tree 6622. Bifurcated at base and covered with ivy.

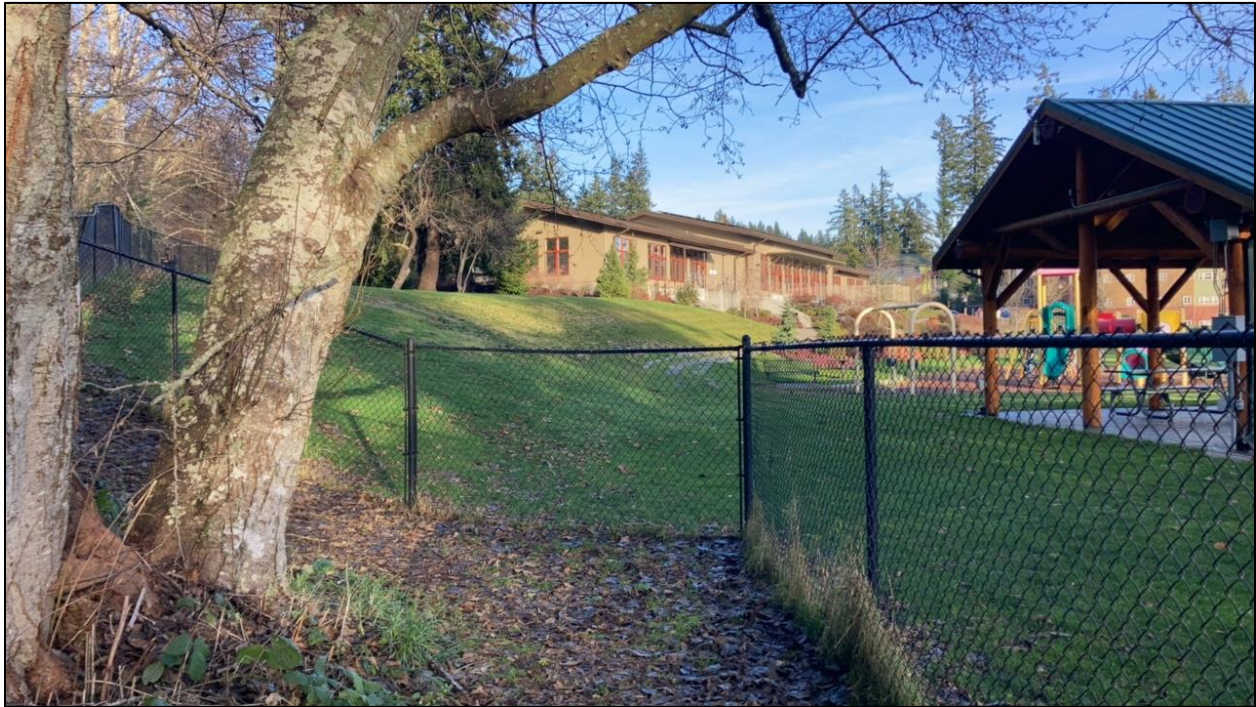
Photo 24: Tree 6623. High risk with fence and gazebo as targets.

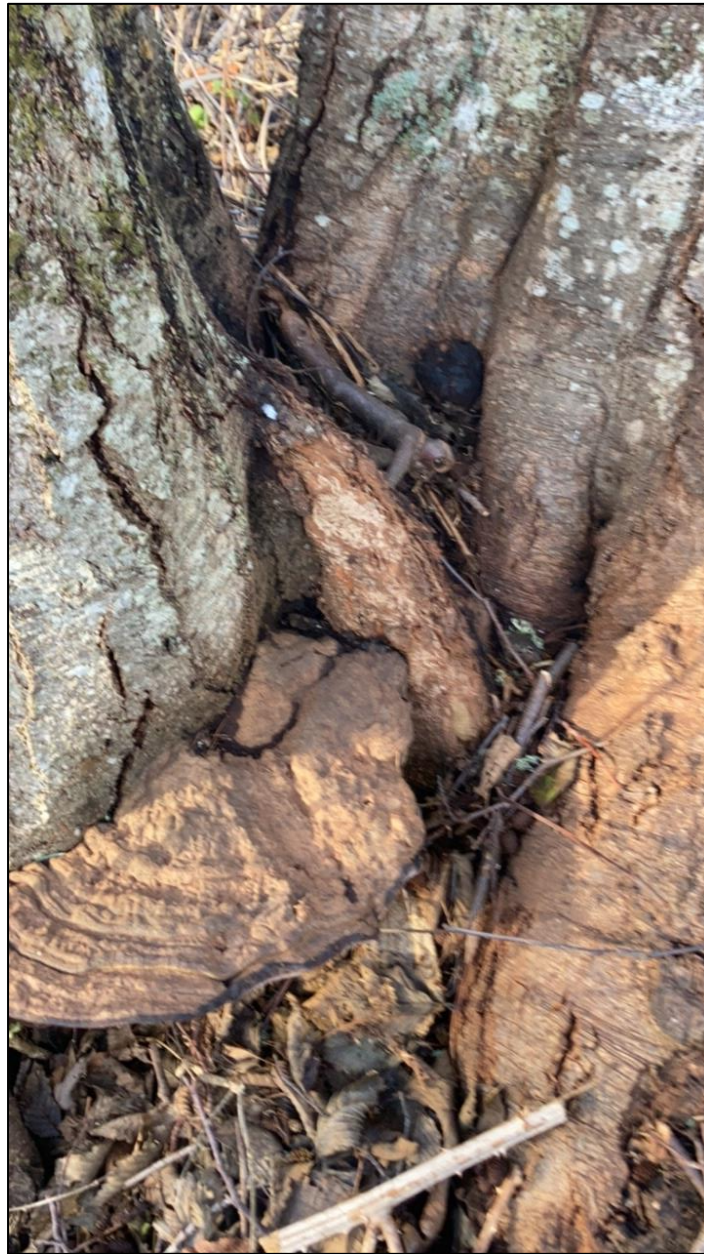
Photo 25: Tree 6623 with Ganoderma applanatum and Kretzschmaria deusta at base.

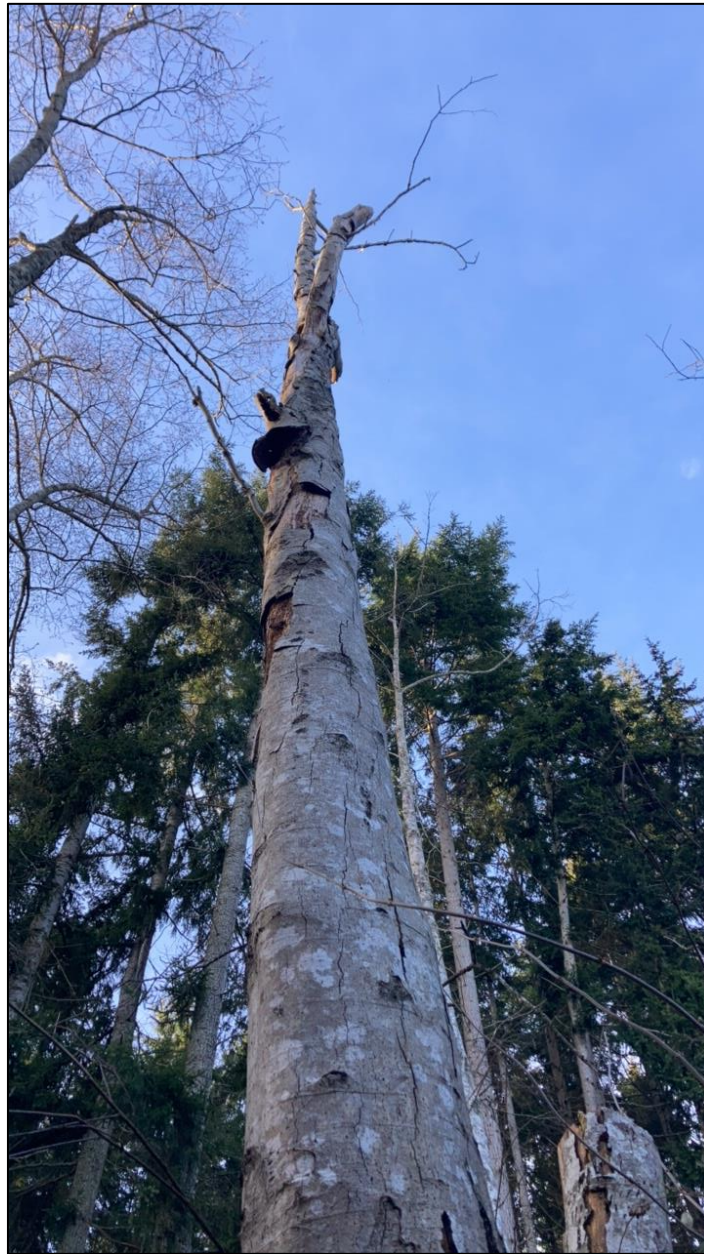
Photo 26: Tree 6624. Snag/dead tree.
