Village Green Metropolitan Park District

Village Green Metropolitan Park
26159 Dulay Rd NE | Kingston, WA 98346
Kitsap County Parcel: 262702-4-089-2009

Title – Tree Risk Assessment

Date – Jan 2023

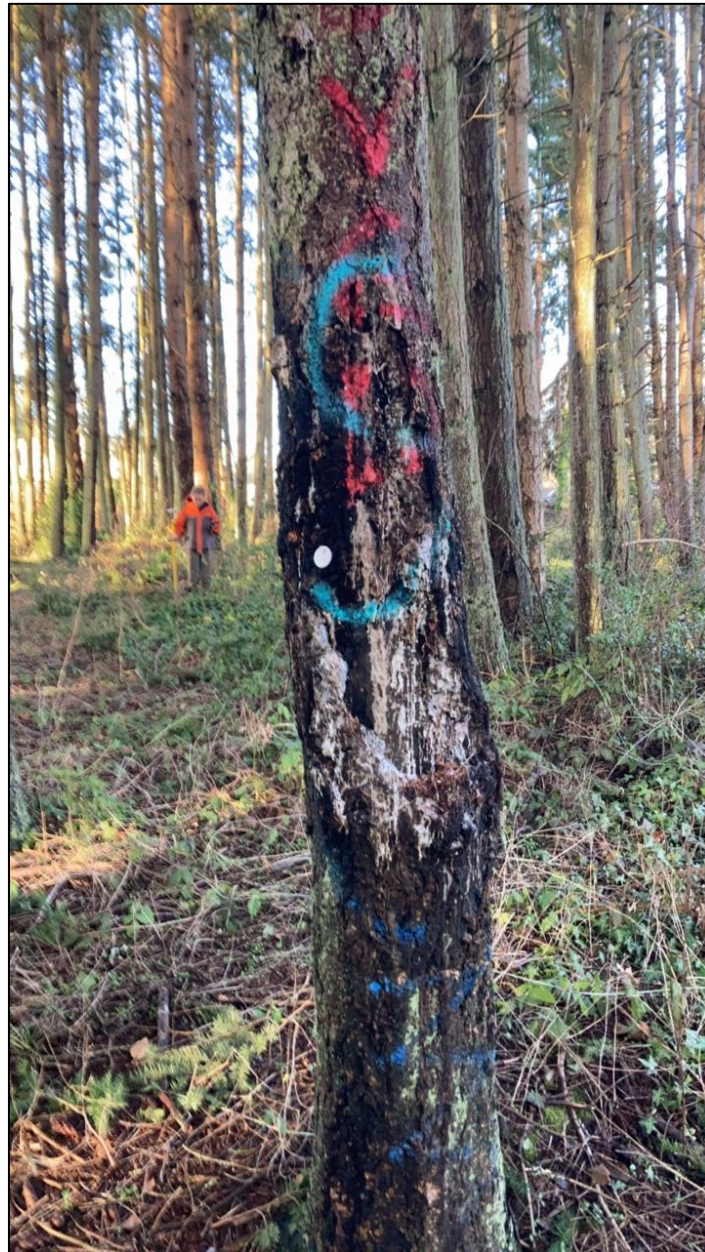
Photo 27: Tree 6625. Wound at base.

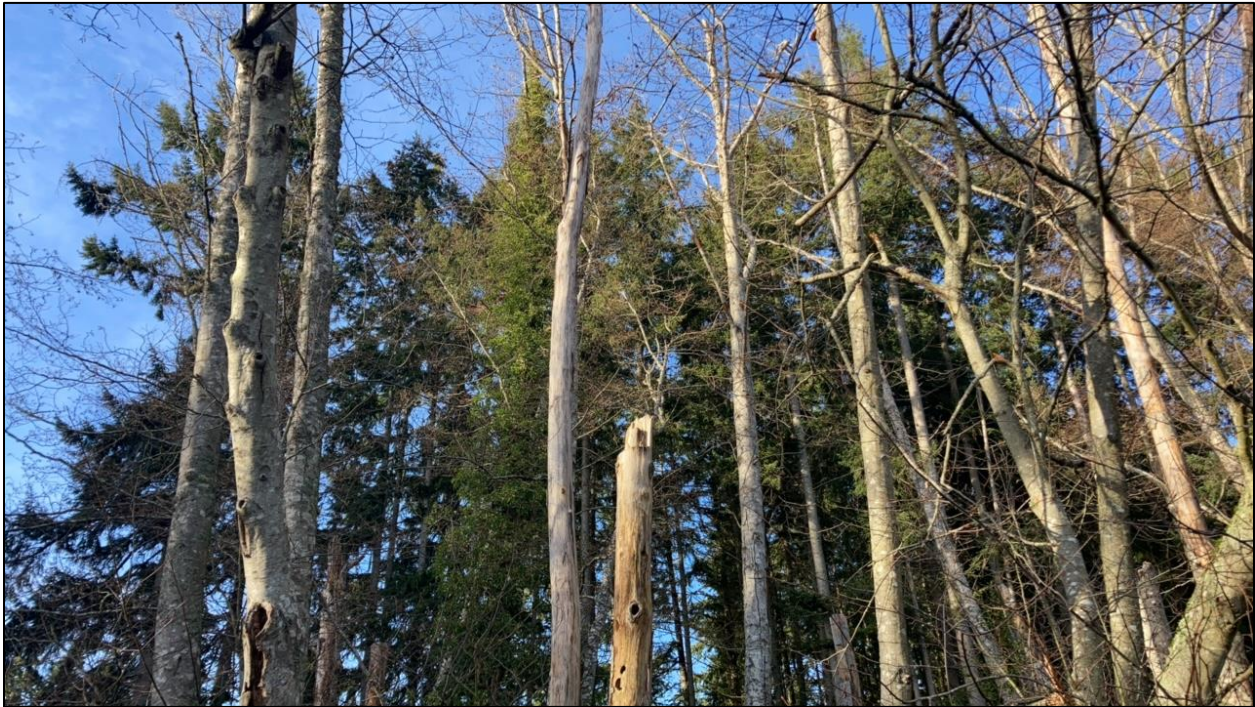
Photo 28: Tree Group 1. Multiple dead tops.

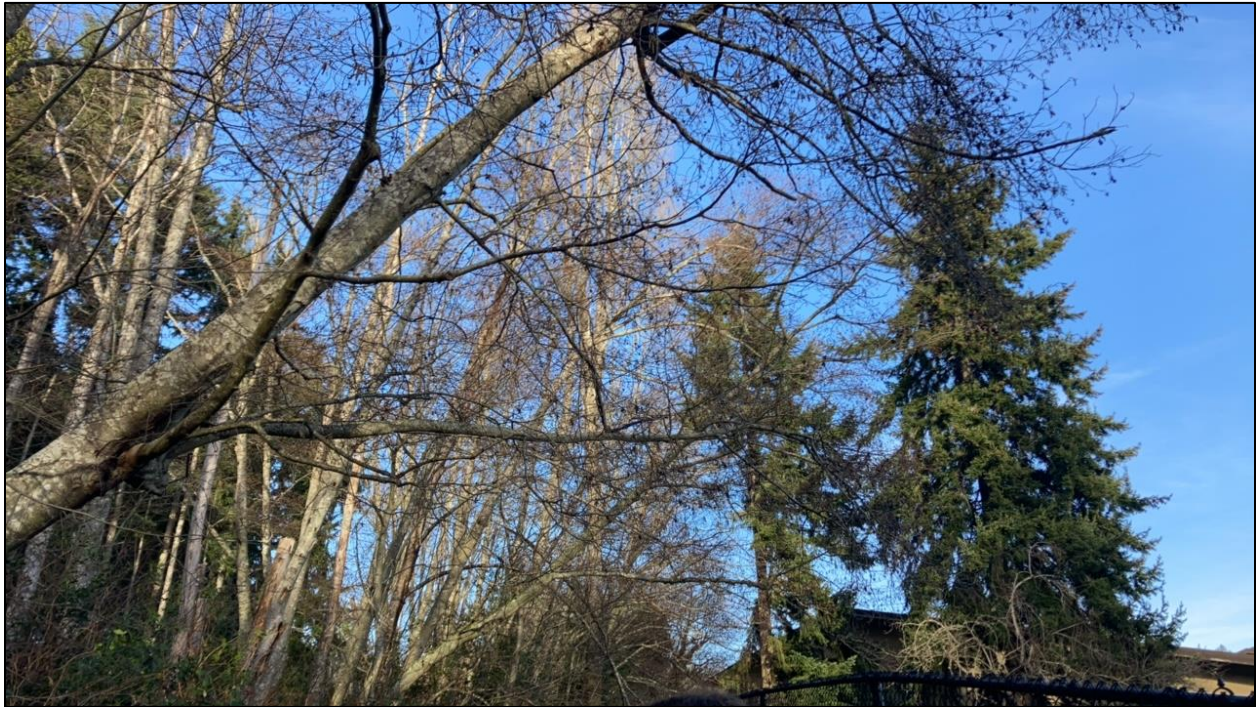
Photo 29: Red alder tree Group 2. Red alder tree leaning over trail.

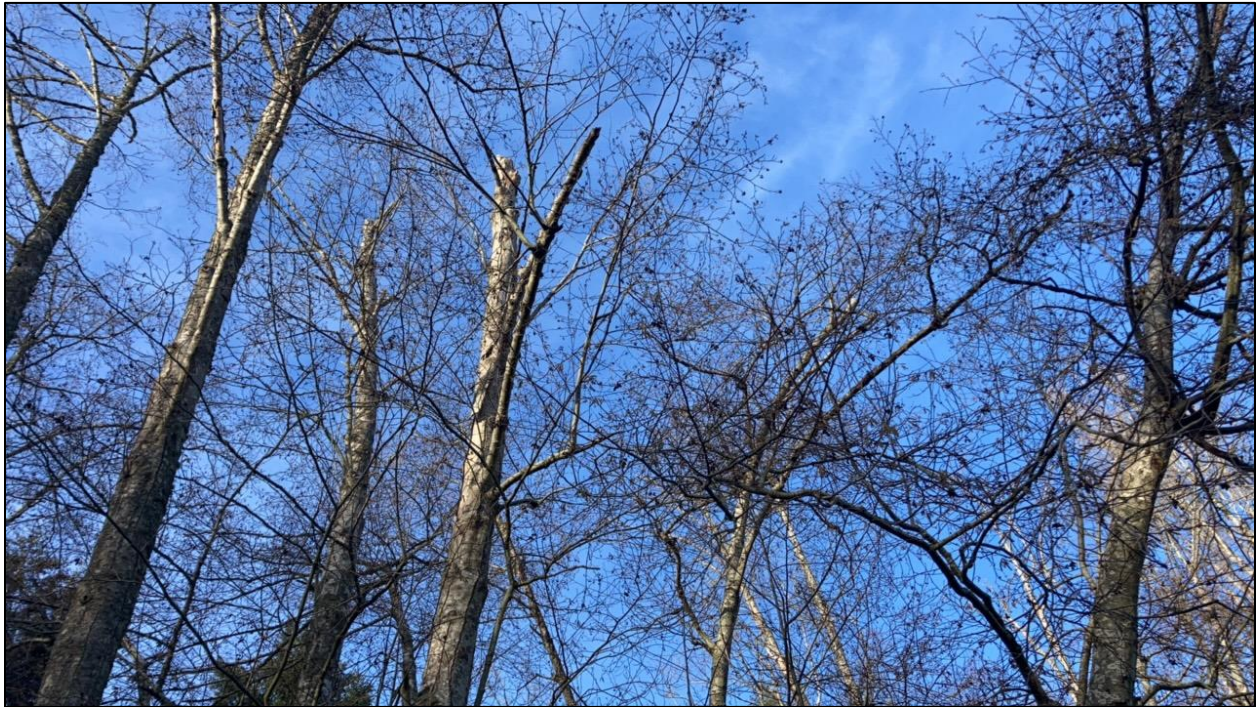
Photo 30: Red alder tree Group 2. Dead tops.

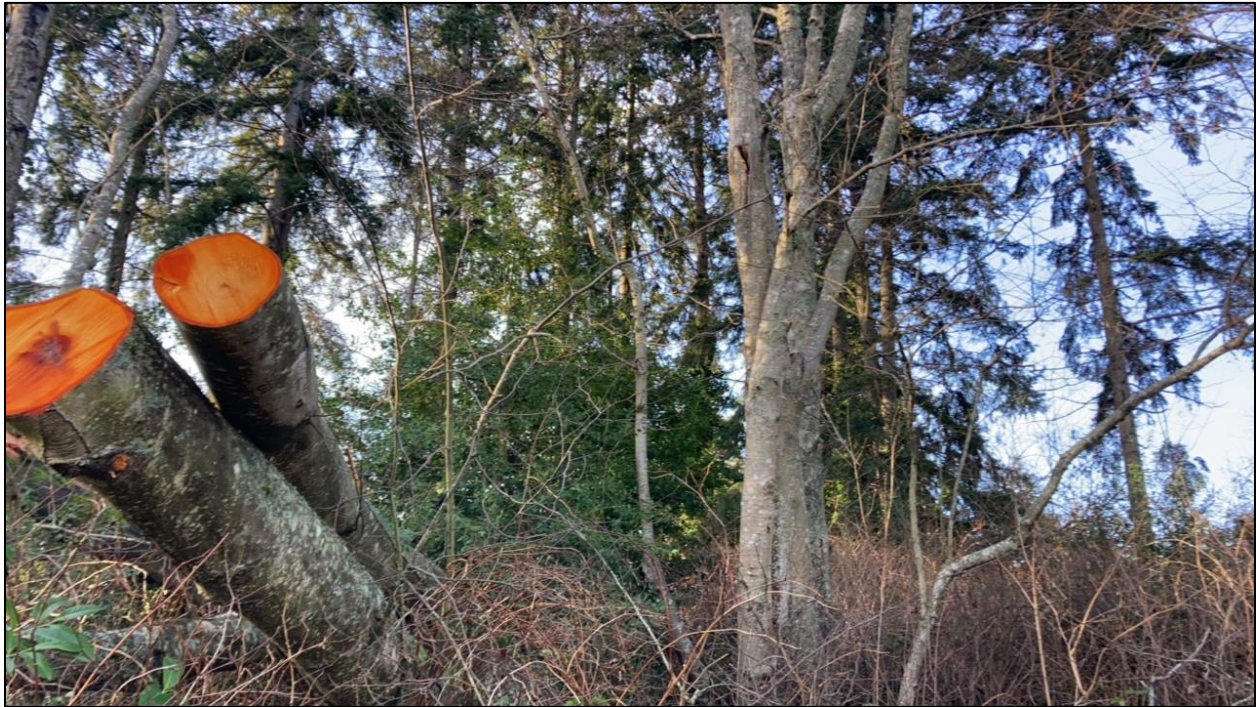
Photo 31: Red alder tree Group 3. Red alders with dead tops next to recently failed red alder tree.

3	Red alder <i>Alnus rubra</i>	Stream Buffer		H	Trail/ Fence	<ol style="list-style-type: none"> 1) Next to a recently failed red alder. 2) Group of 5 trees with multiple dead branches larger than 3-inches in diameter and some dead tops. 3) Located close to stream-the roots might get regularly inundated. 4) Could not observe base of trees because of location. 5) Remove trees or convert to habitat trees.
6624	Red alder <i>Alnus rubra</i>	Wetland and Stream Buffer	22	H	Trail	<ol style="list-style-type: none"> 1) Dead tree. 2) Reduce height of snag to 15 feet. 3) Remove side branches.
6625	Douglas-fir <i>Pseudotsuga menziesii</i>	Stream Buffer	12	L	Trail	<ol style="list-style-type: none"> 1) Suppressed tree with 1x1 foot wound about 5 feet off ground. 2) Monitor on a 3-year basis.
